TEST REPORT

Lucideon Reference: UK213654 (QT-65319/1/JB)/Ref. 1

Project Title: Testing of HURST TRACKWALL Brick Slip System to EAD 090019-00-0404:2016 & EAD 090062-00-0404:2018

Client: Hurst Contracts Ltd

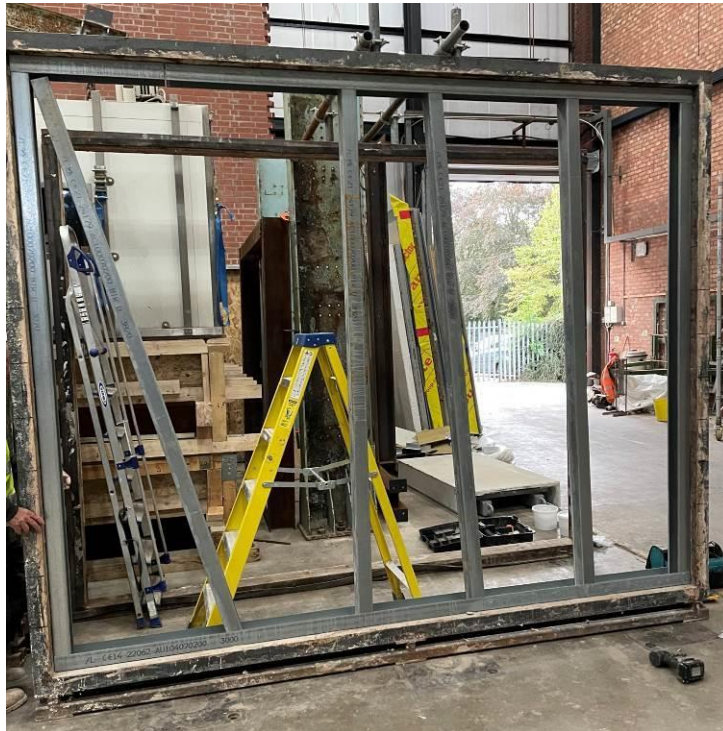
Plate 1 – Installation of Base and Support Rails

3000 x 2.7 mm base rail fixed to top and bottom of provided steel frame using E-VS BOHR 3 FLT 4.8 mm x 38 mm fixings at 400 mm centers. Extra rail was cut to size to make up 3.2 m system width.

3000 x 2.7 mm support rails knocked into place with a mallet in-between the base rails flush against the sides of the steel frame and fixed to the steel frame using E-VS BOHR 3 FLT 4.8 mm x 38 mm fixings at 400 mm centers. Rail was cut to size to be able to fit into the 2.6 m high frame.

Additional support rails were knocked into place based on 600 mm centers. Each support rail was fixed using Hexagon set screw fixings at the top and bottom base-support rail intersect.

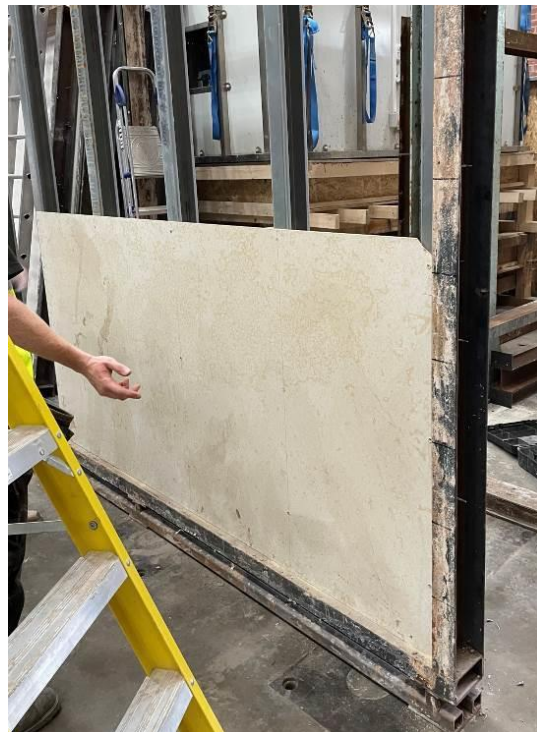
Plate 2 – Application of Y-Wall Boards to Base and Support Rails

2400 x 1200 x 12 mm Y-wall boards were fixed to the rails using E-VS BOHR 3 FLT 4.8 mm x 38 mm fixings at 600 mm horizontal centers and 400 mm vertical centers. This is repeated until the Y-wall had filled the 2.6 x 3.2 m frame. The Y-wall was cut to size where needed.

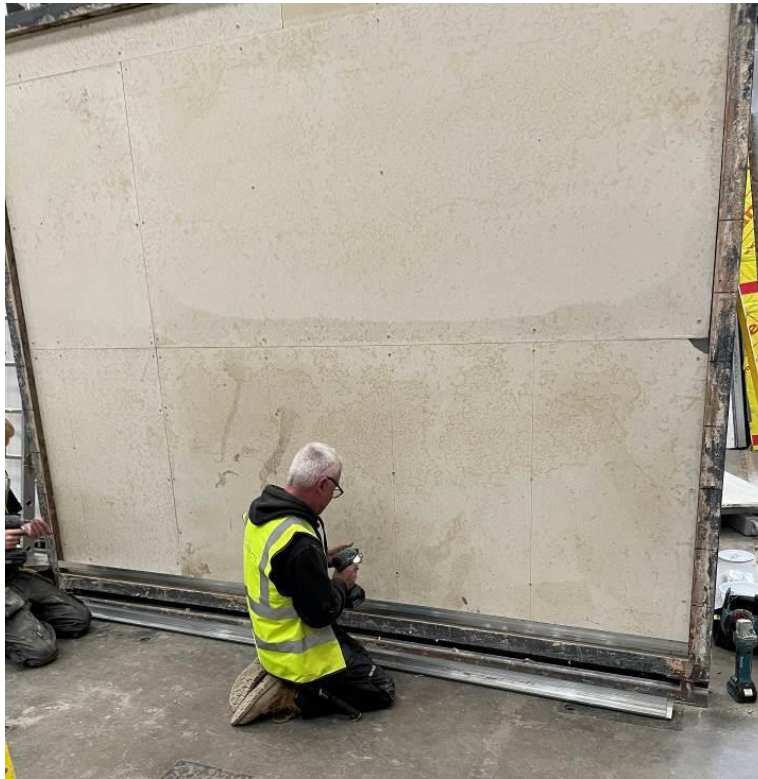
Plate 3 – Application of 'Z' Rails Upon Y-Wall

A 2.4 mm Z-rail was fixed through the Y-wall at the base of the steel frame into the base and support rails using E-VS BOHR 3 FLT 4.8 mm x 38 mm fixings. Additional Z-rails were fixed horizontally across the Y-wall surface separated by 400 mm centers.

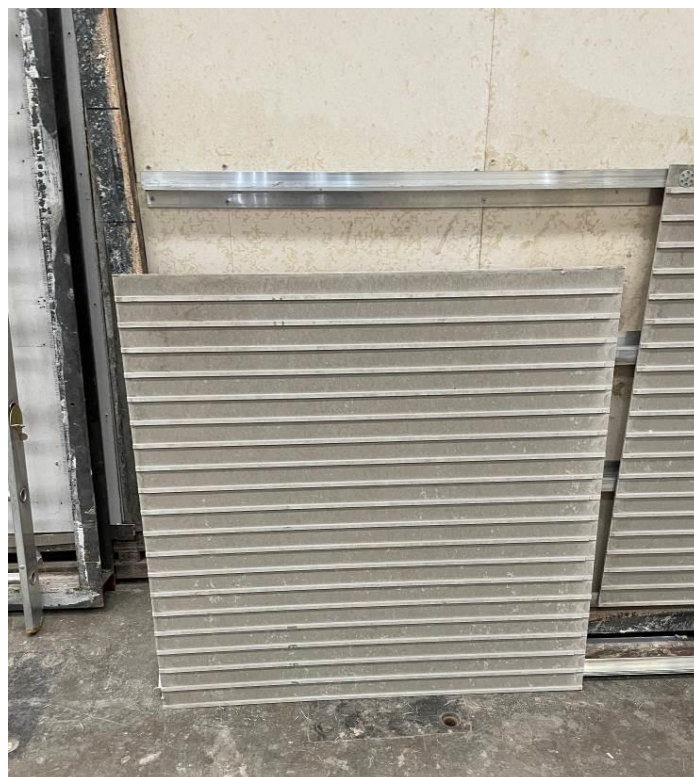
Plate 4 – Fixing of Brick Slip Carry Board Upon 'Z' Rails

1200 x 1200 mm brick slip carry board was mechanically fixed to the Z-rails using E-VS BOHR 3 FLT 4.8 mm x 38 mm fixings and washers at 300 mm horizontal and 400 mm vertical centers.

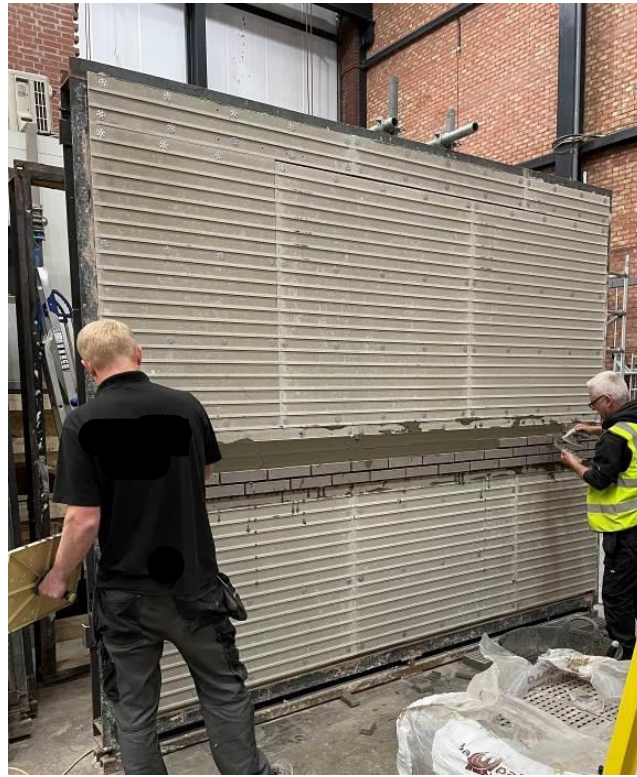
Plate 5 – Application of Tile Adhesive and Brick Slips

A 20 kg bag of ULTRA TILEFIX ProFlex SP Tile Adhesive was prepared as per the package instructions and mixed with 4.2–4.5 L of water until an even consistency was achieved. The tile adhesive was applied to the carry board and levelled flush with the board's peaks.

While the tile adhesive is still wet the Grey Escorial Brick Slips were applied to the carry board in between the peaks of the carry board. Each row of brick slips was staggered by half a brick slip in relation to the rows above and below. The cladding system was left for 24 hours while the tile adhesive set.

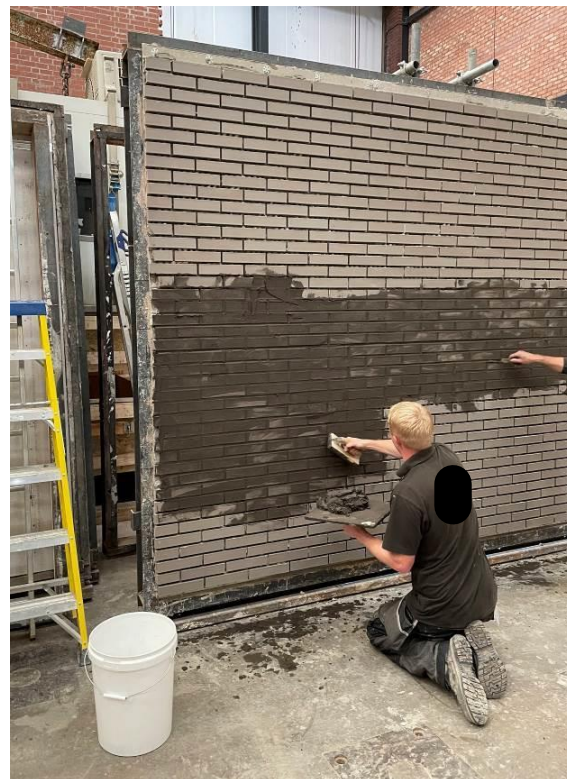
Plate 6 – Application of Plasticizer and Cement Mixture

A mixture of Bostik Concentrated Mortar Plasticizer and Blue Circle Mastercrete Cement was prepared and mixed into an even consistency and applied in between the joints and over the surface of the cladding system ensuring all gaps were filled. Excess was removed and a motor pointer was used at each brick slip joining for a stylized finish.

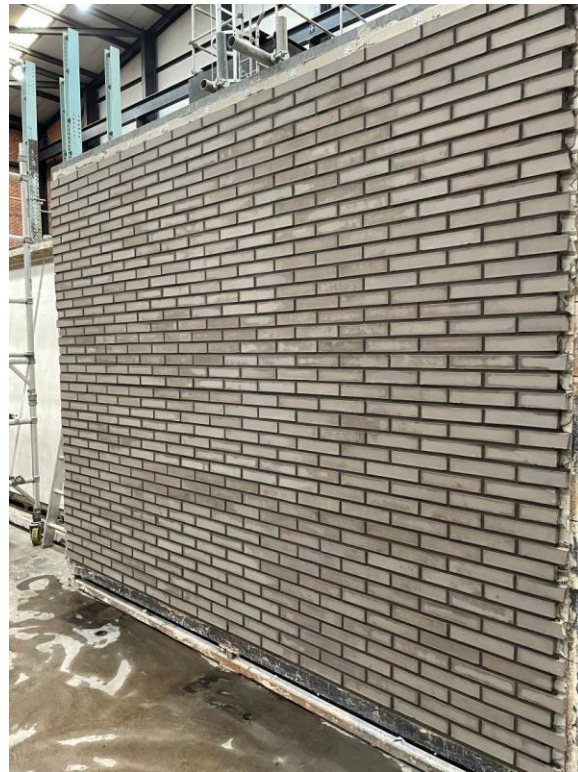
Plate 7 – Finished Wall

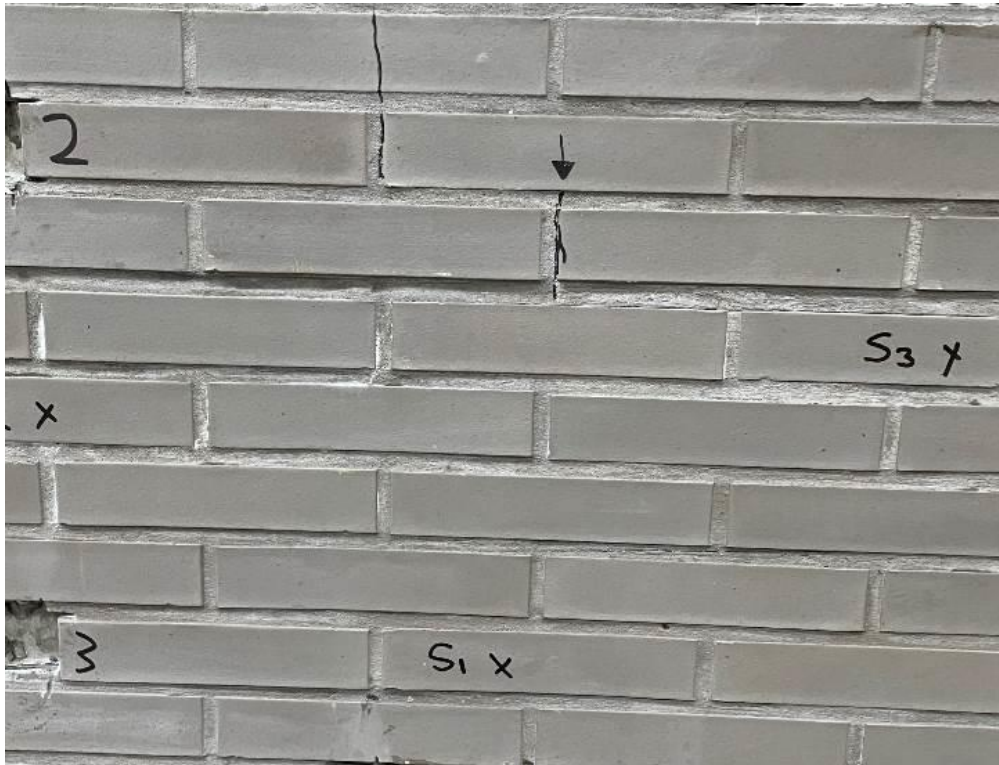
Plate 8 – Soft Body Impact of HURST TRACKWALL Brick Slip Cladding System

Testing was carried out in accordance with EAD 090019-00-0404 Annex C and EAD 090062-00-0404 Annex G. A rigid scaffold framework was constructed to hold the impactor such that the center of the soft body impactor was aligned with the brick slip wall.

The impact test consisted of a bag (3 kg for 10 Joules and 60 Joules impacts and 50 kg for 300 Joules and 400 Joules impacts) suspended by a 3 m steel wire swung from differing drop heights, as stated in Table 2.

Impact Energy (Joules)	Observations
10	No Damage
60	No Damage
300	No Damage
400	No Damage

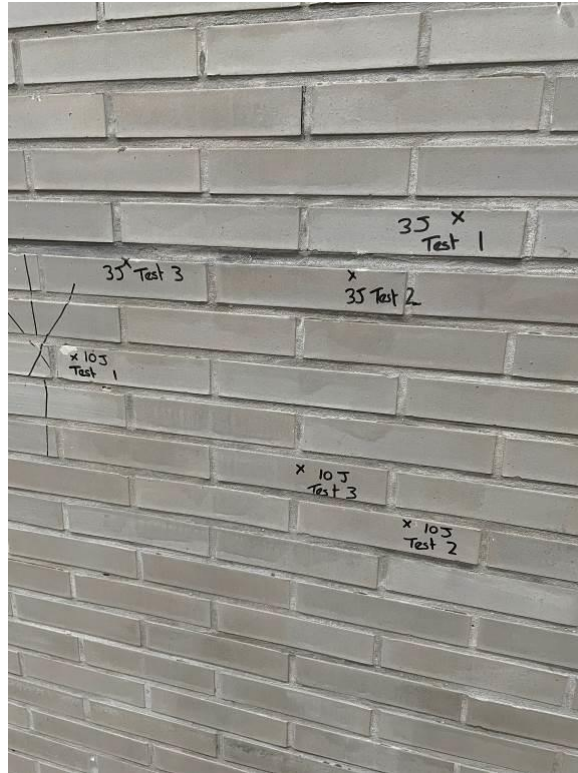
Plate 9 – Hard Body Impact of HURST TRACKWALL Brick Slip Cladding System

To obtain an impact energy of 3 Joules, a 0.5 kg steel ball was released from a drop height of 613 mm and to obtain a 10 Joules impact energy, a 1 kg steel ball was released from a drop height of 1020 mm.

Location	Diameter Under 3 Joules Impact Energy	Cracking	Diameter Under 10 Joules Impact Energy	Cracking
1	No Damage	No	No Damage	No
2	No Damage	No	No Damage	No
3	No Damage	No	No Damage	No

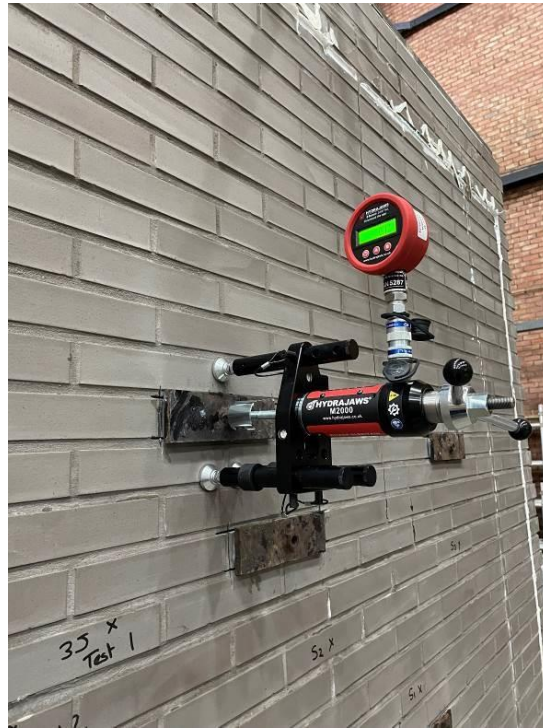
Plate 10 – Typical Bond Strength Test Arrangement

A 230 mm x 48 mm steel plate was bonded to the face of the sample with an epoxy resin and allowed to cure for 24 hours. A centralized tensile load was provided to the plate at a rate of 1-10 mm/min through a tensile load machine until failure was recorded.

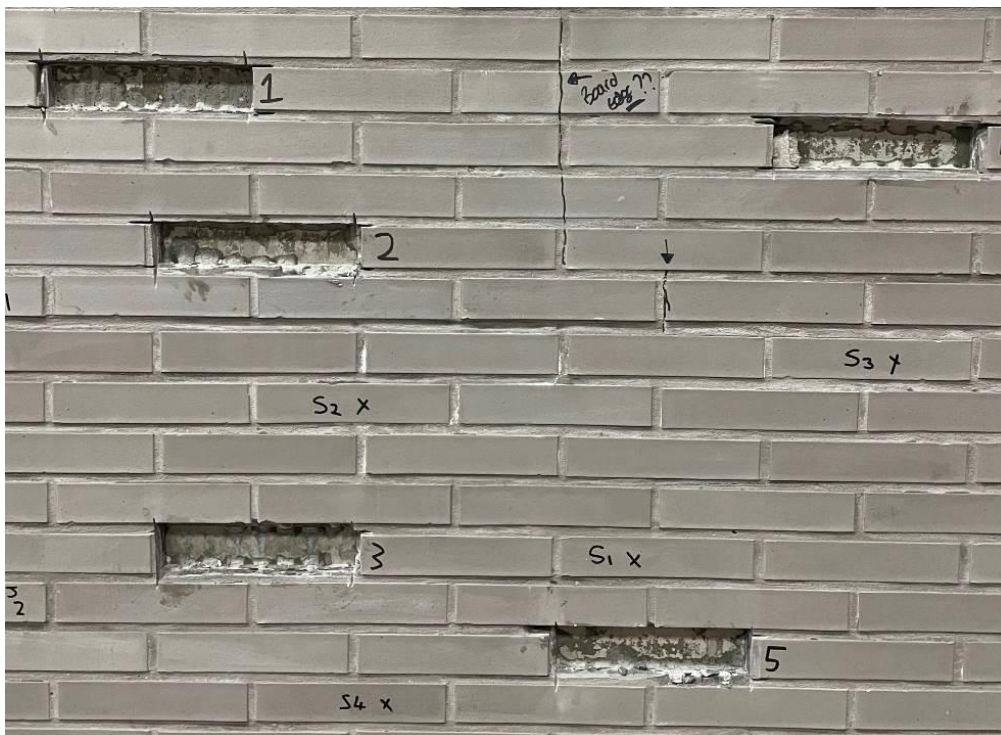
Plate 11 - Bond Strength Failures on HURST TRACKWALL Brick Slip Cladding System

Sample Size (mm)	Test Number	Ultimate Load (kN)	Ultimate Strength (N/mm ²)	Mode of Failure
230 x 48	a	5.20	0.47	At substrate and back of brick slip interface
	b	5.90	0.53	At substrate and back of brick slip interface
	c	3.50	0.32	At substrate and back of brick slip interface
	d	5.50	0.50	At substrate and back of brick slip interface
	e	5.80	0.53	At substrate and back of brick slip interface
Mean		5.18	0.47	-

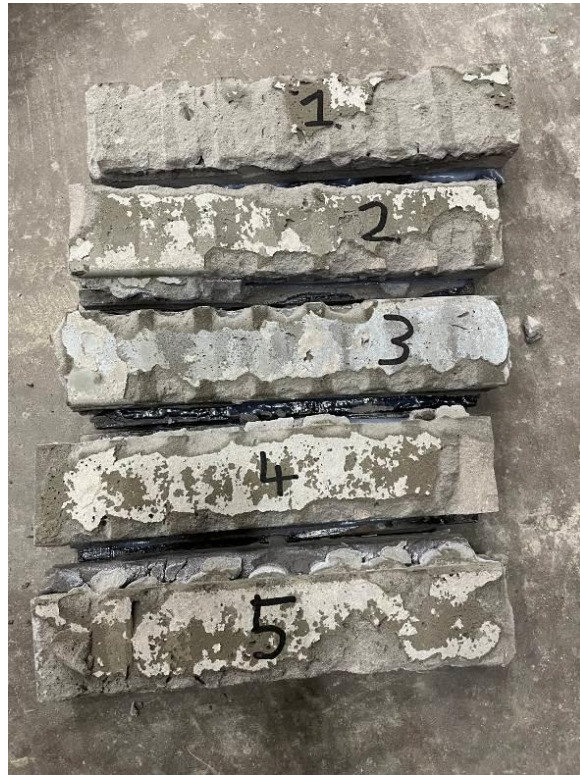
Plate 12 - Bond Strength Failed Brick from HURST TRACKWALL Brick Slip Cladding System
